Drone Photogrammetry and AI for Monitoring Paved Roads Distresses in Cameroon – A Case Study of Elig-Effa-Melen-EMIA Road Section in Yaoundé

MEKANDA YAKAN Eugène Salomon ¹, LIMALEBA Roger Blaise ², BIKIE Gerald Anicet ³

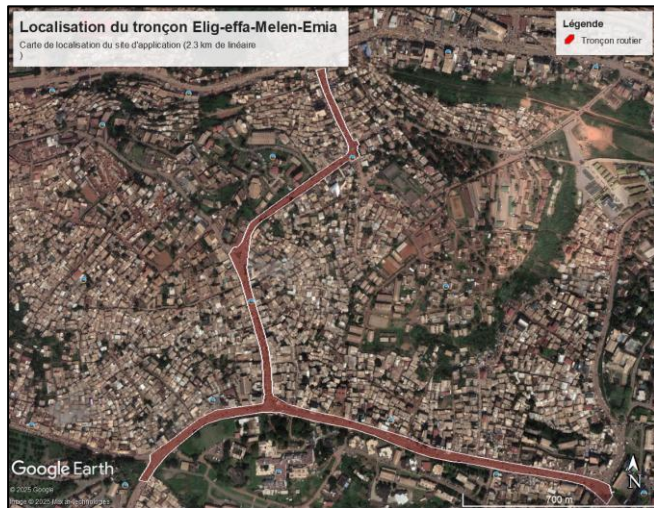
Figure 2 : Elig-Effa-Melen-Emia Road section

The case study is conducted in Yaoundé, Cameroon's capital, which provides a representative urban environment with diverse road conditions and common degradation types. Within Yaoundé, a specific road section known as Elig-Effa–Melen–Emia (approximately 2.5 km long) (Figure 2), was selected for detailed analysis. This section was chosen due to its varied pavement conditions and observable distresses, making it an ideal testbed for the proposed monitoring system.

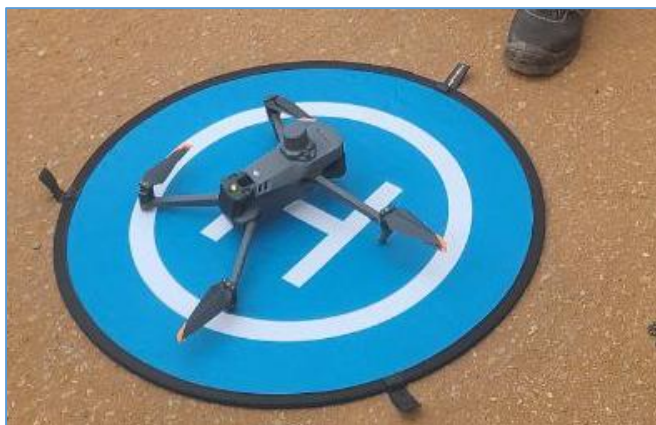
Aerial data were acquired using a *DJI Mavic 3 Enterprise (M3E)* drone (Figure 3). The M3E is a compact quadcopter equipped with an RTK (Real-Time Kinematic) module for centimeter-level geolocation accuracy of images. It carries an integrated 20 MP wide-angle camera (4/3" CMOS sensor) capable of high-resolution capture even in lower light conditions. We planned flight missions to achieve a ground sampling distance (GSD) of 2-3 cm/pixel on the ground, which is sufficient to resolve fine pavement details such as small cracks. The drone was flown at an altitude and overlap configuration optimized for photogrammetry: typically, 80% forward overlap and 70% side overlap between images, ensuring robust 3D reconstruction and full coverage of the road surface.

Figure 3 : DJI Mavic 3 Enterprise

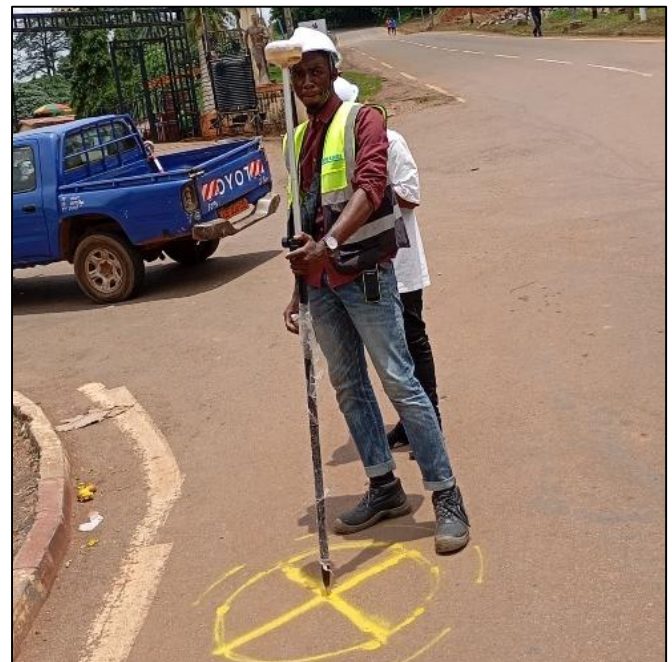
To enhance absolute positioning accuracy of the orthomosaic, we placed Ground Control Points (GCPs) on and around the road prior to flying. These GCPs were marked on the pavement (painted targets at easily identifiable locations) and precisely surveyed with dual-frequency GNSS receivers in Network RTK mode (Figure 4).

An average horizontal accuracy of ± 1 cm and vertical accuracy of ± 2 cm was achieved for the GCP coordinates. The spatial arrangement of GCPs covered the extremities and key points along the road section to support an accurate georeferencing of the photogrammetric models. The data acquisition campaign took place over a one-month period, accounting for suitable weather windows and coordinating around traffic to minimize disruptions.

Figure 4: GCP surveying

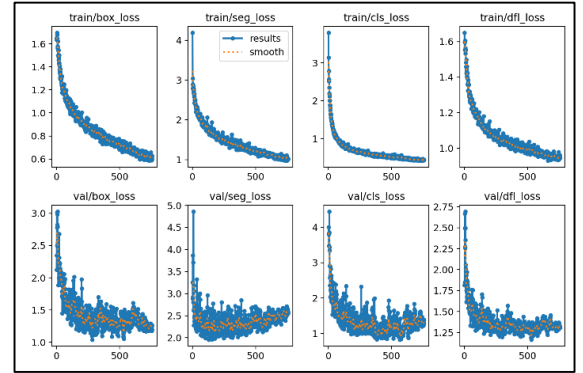
The analysis of the training curves (Figure 8) was essential to understand the model's learning process and to identify potential issues such as overfitting or underfitting. The training losses (train/box_loss, train/seg_loss, train/cls_loss, train/dfl_loss) decrease rapidly and then stabilize, indicating proper convergence. The validation losses (val/box_loss, val/seg_loss, val/cls_loss, val/dfl_loss) follow the same trend with normal, mild fluctuations and no marked divergence from training.

Regarding the metrics, precision reaches about 0.86 for both detection and segmentation, while recall is around 0.70 for detection and 0.78 for segmentation. The mAP at IoU 0.50 is approximately 0.75 (B) and 0.73 (M), whereas mAP@0.50-0.95 is lower—0.48 (B) and 0.38 (M)—reflecting the increasing strictness of higher IoU thresholds.

Figure 8: Training loss curves (A) and metrics curves (B)

Regarding the training process, the decrease followed by stabilization of train/val losses points to stable learning, with no marked overfitting.

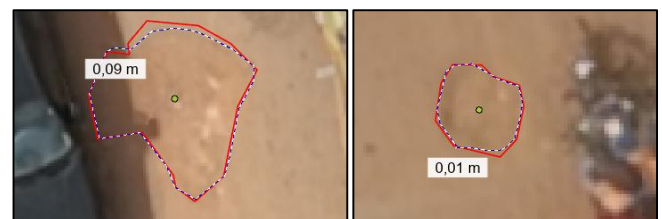
As the Elig-effa-Melen-Carrefour EMIA section was rehabilitated during the study period, direct field surveys for validation were not feasible. Therefore, an alternative, scientifically justified validation strategy was adopted, based on comparing the results of our Python workflow with manual digitalization on the orthomosaic (Figure 16). This approach was supported by:

Figure 16: Manually Digitized polygons and Python workflow generated polygons

While the visual detection and manual digitalization method revealed more degradations (457 degradations, 19 more) than those automatically detected and segmented, the comparison primarily focused on a subset of degradations detected by both
